FORD:

2015-2016 Mustang

Some 2015-2016 Mustang vehicles equipped with a 2.3L GTDI engine may exhibit a heavy continuous blue smoke with a burning oil smell after idling 10 minutes or longer.

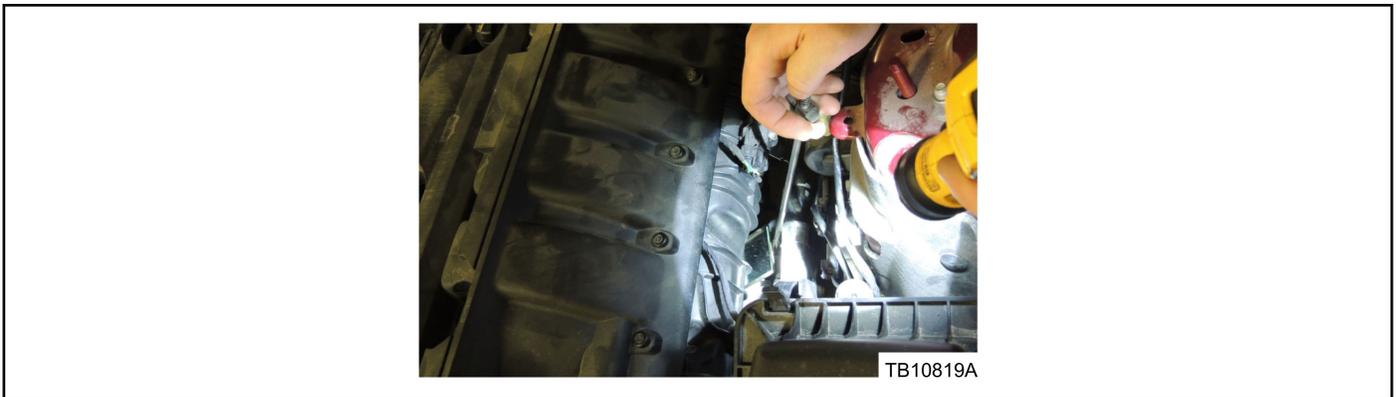
Figure 1 - Article 15-0192

1. Check the part tag on the crankcase vent oil separator by placing a mirror in front of the left motor mount. (Figure 1)

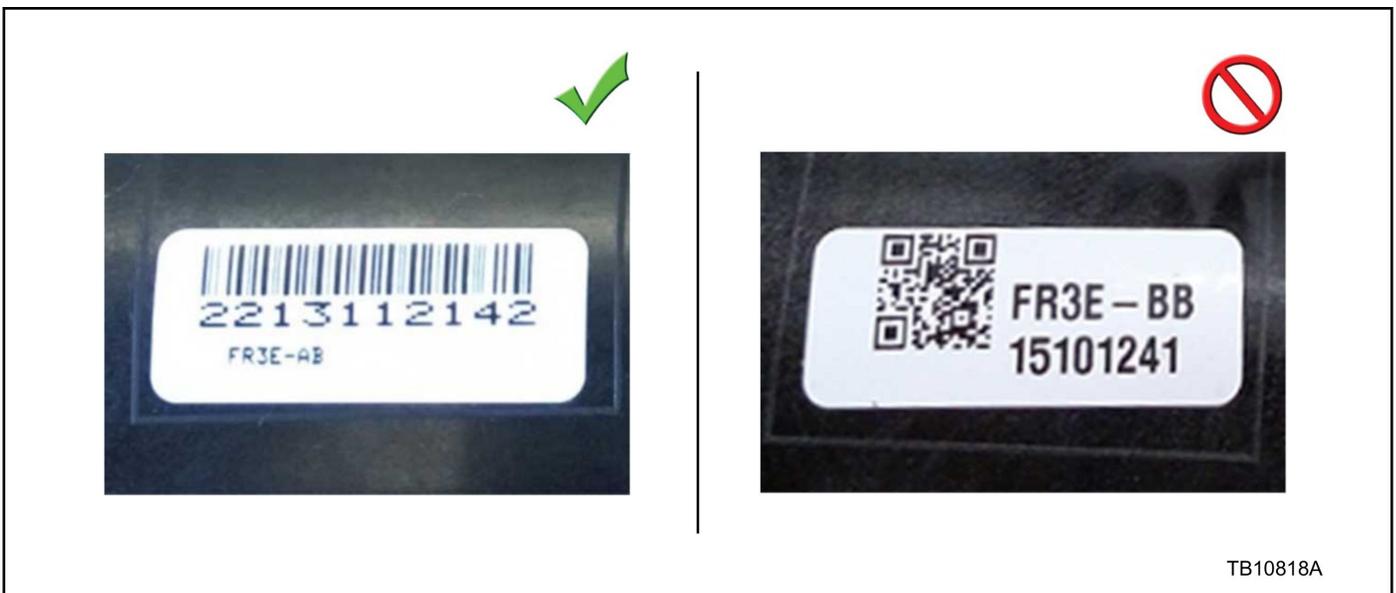
Figure 2 - Article 15-0192

2. Does the part tag have a bar code? (Figure 2)

- a. No - this article does not apply. Refer to Workshop Manual, Section (WSM), Section 303-00 for normal diagnosis.
- b. Yes - this vehicle is not equipped with a high flow crankcase vent oil separator system. Proceed to Step 3.
- 3. Replace the crankcase vent oil separator. Refer to Workshop Manual, Section 303-08.
- 4. Reprogram the powertrain control module (PCM) to the latest calibration using IDS release 98.03 or higher. Make sure you are connected to the internet when entering module programming to obtain the latest updates. Calibration files may also be obtained at www.motorcraftservice.com
 - a. When the IDS tool prompts the question: Is vehicle equipped with FR3E-6A785-BB or later crankcase vent oil separator? Answer; Yes to make sure the vehicle is updated with the correct level PCM software.
